STORMWATER Projects Update

Presented to
UTILITIES COMMITTEE
JUNE 9TH , 2015

Presented to
UTILITIES COMMITTEE
September 22nd , 2015

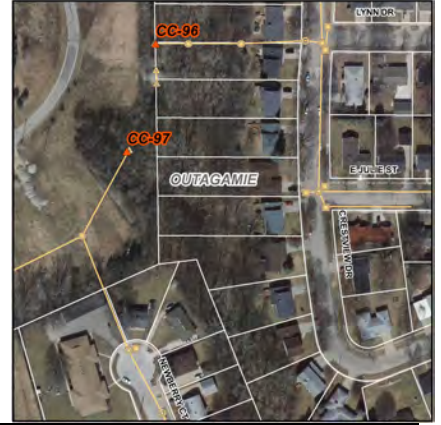
Indicator	Description	Comments
Outfall Damage:		
Deposits / Stains:		
Abnormal Vegetation:		
Poor Pool Quality:	Oil Sheen	
Pipe Benthic Growth:

Overall Outfall Characterization: Potential (Presence of one or more indicators)
Non-Illicit Discharge Concerns: No
Comments: Infrastructure satisfactory. Oil sheen present, brown suds, and a 6.0 ppm ammonia residual present. Source is a cracked storm sewer on the premises of the WWTP, allowing biosolids leachate to enter the outfall. City is presently rehabilitating the pipe of concern.

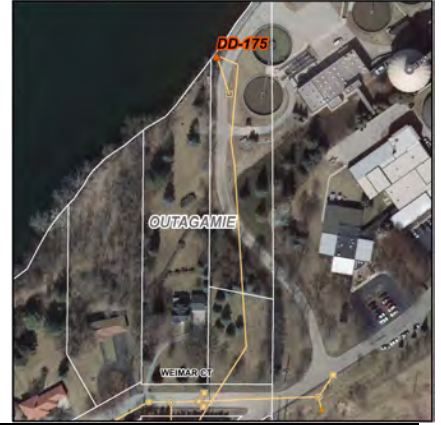
Indicator	Description	Comments
Outfall Damage:		
Deposits / Stains:		
Abnormal Vegetation:		
Poor Pool Quality:	Oil Sheen	Very slight sheen on standing water in outfall.
Pipe Benthic Growth:

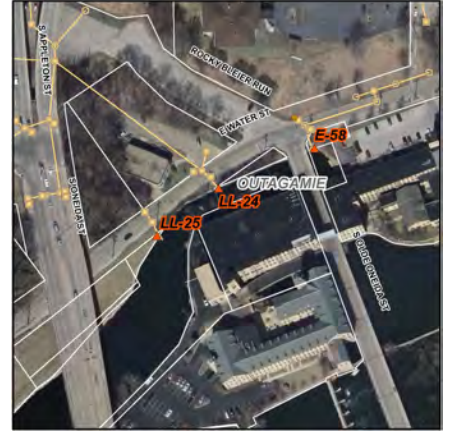
Indicator	Description	Comments
Outfall Damage:	Spalling, Cracking Or Chipping	Headwall is cracked around pipe. Exposed rebar below pipe.
Deposits / Stains:		
Abnormal Vegetation:		
Poor Pool Quality:		
Pipe Benthic Growth:	Green

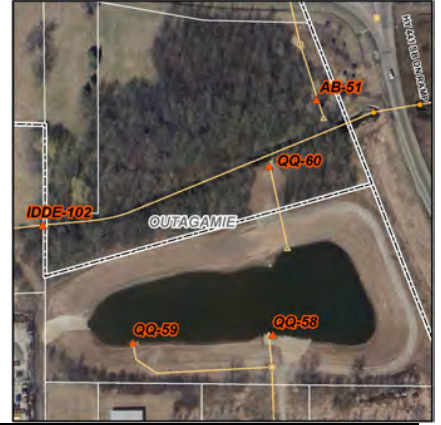
Indicator	Description	Comments
Outfall Damage:		
Deposits / Stains:		
Abnormal Vegetation:		
Poor Pool Quality:	Colors	Cloudy water observed at time of inspection.
Pipe Benthic Growth:

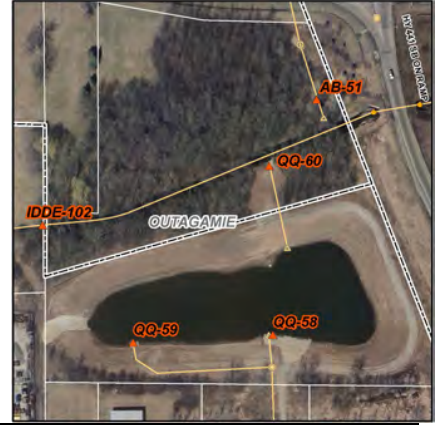
Indicator	Description	Comments
Outfall Damage:		
Deposits / Stains:		
Abnormal Vegetation:		
Poor Pool Quality:	Colors	Cloudy water observed at time of inspection.
Pipe Benthic Growth:

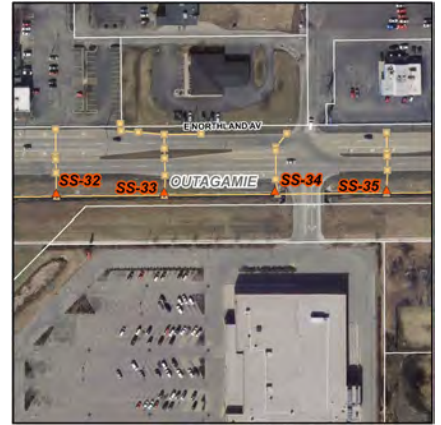
Indicator	Description	Comments
Outfall Damage:	Spalling, Cracking Or Chipping	One side of the concrete apron is chipped.
Deposits / Stains:		
Abnormal Vegetation:		
Poor Pool Quality:		
Pipe Benthic Growth:

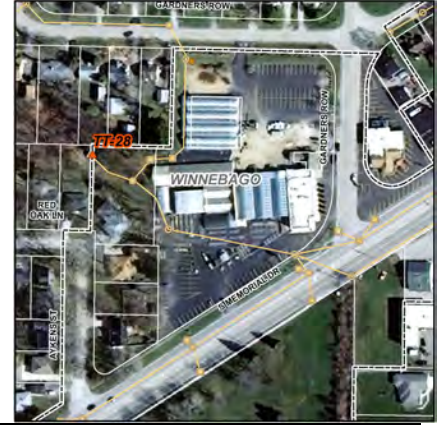
Outfall Location: Storm sewer discharges to Red Oak Ravine. (Formerly TT-26-X)
Outfall Description: 72

Indicator	Description	Comments
Outfall Damage:		
Deposits / Stains:		
Abnormal Vegetation:		
Poor Pool Quality:	Excessive Algae	Temper flow diversion for Red Oak Ravine construction.
Pipe Benthic Growth:
