STORMWATER Projects Update

Presented to
UTILITIES COMMITTEE
JUNE 9TH , 2015

Presented to
UTILITIES COMMITTEE
September 22nd , 2015

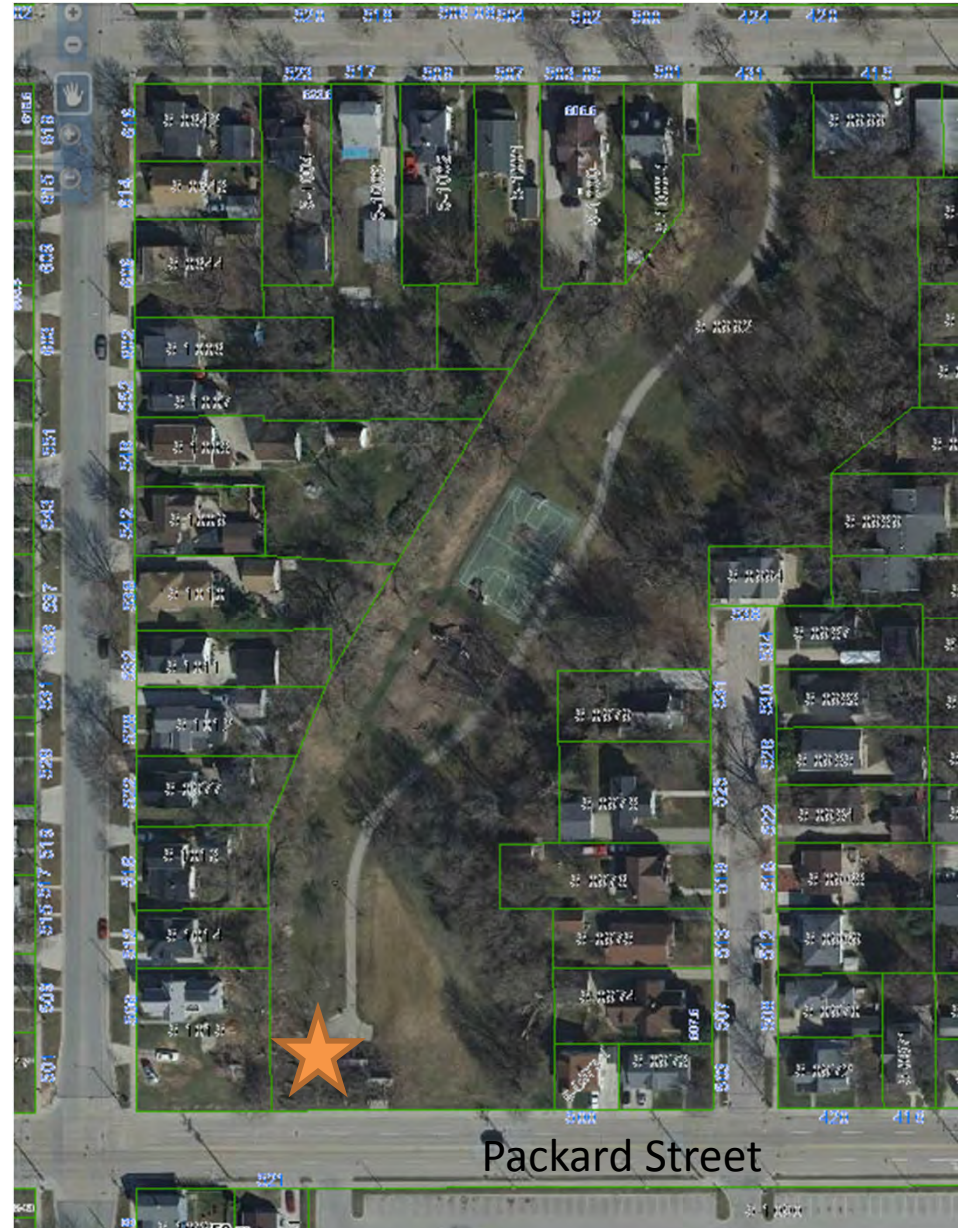
ARBUTUS PARK

- Stormwater Lift Station Maintained by Utilities
- Repairs are increasing
- Initial Evaluation in 2015
- Design/Construct in 2016
- High End Estimate \$140K if replacement needed

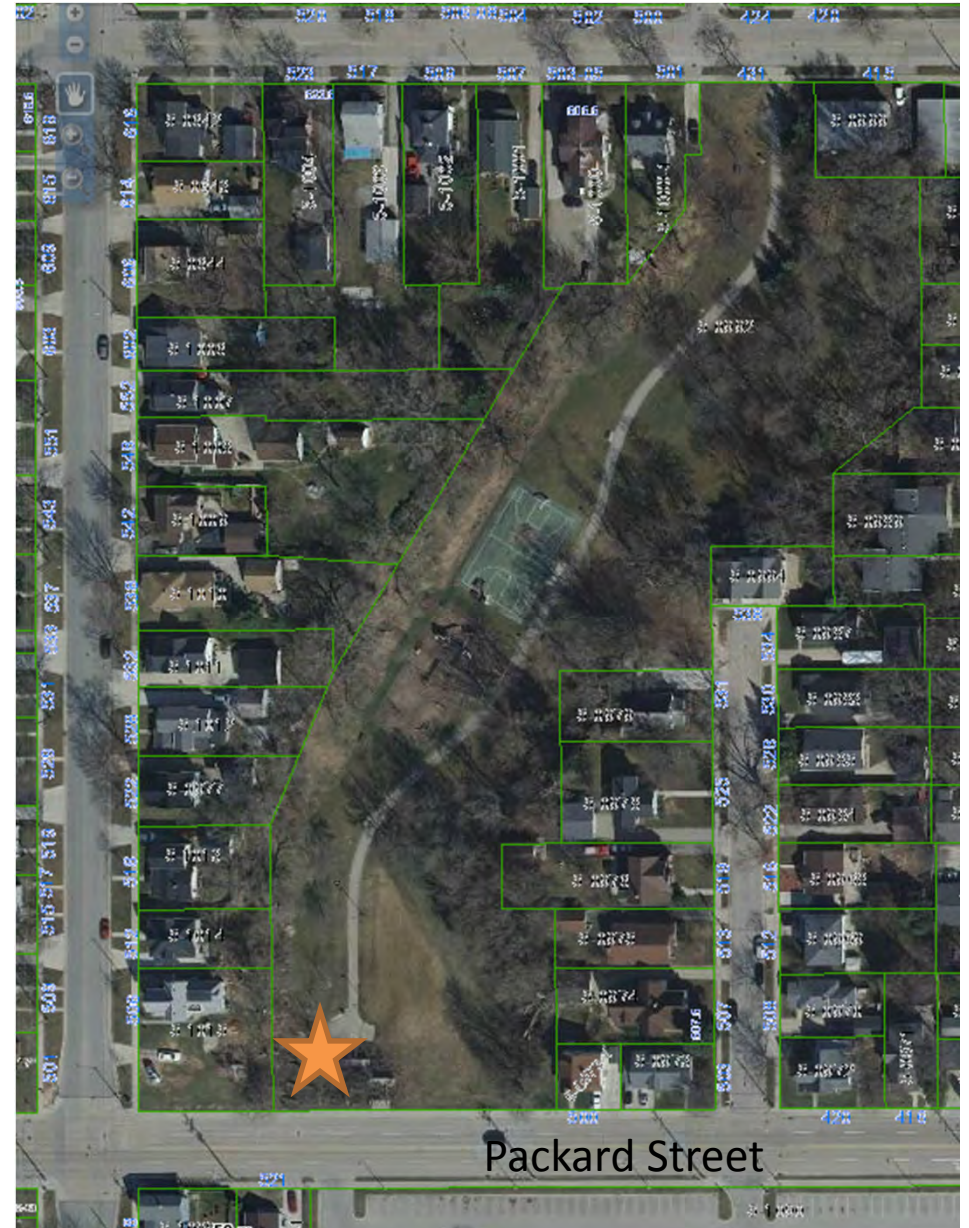
ARBUTUS PARK

- Stormwater Lift Station Maintained by Utilities
- Repairs are increasing
- Received proposals for 2015 Conditions Assessment on September 4
- Design/Construct in 2016
- High End Estimate \$140K if replacement needed

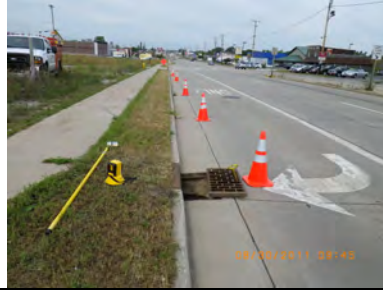
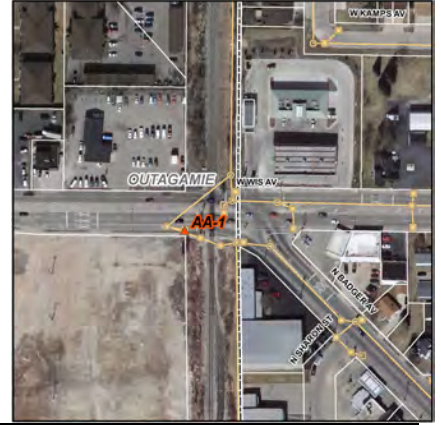
Outfall Description: Concrete MH

Comments: Outfall location: -88.43638667000, 44.27308949240. Cannot safely open due to conditions.

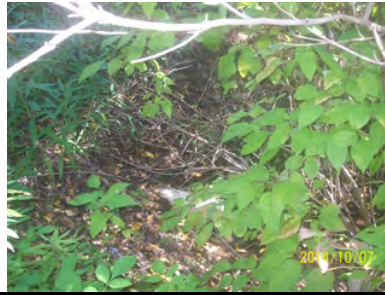
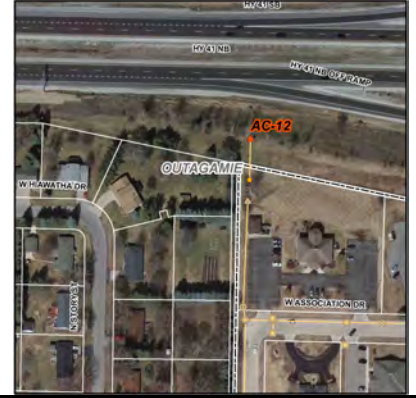
Outfall Location: 8 PVC discharges to USH 41 right-of-way.
Outfall Description: 8

Flow: None
Physical Indirectors: None
Overall Outfall Characterization: Unlikely
Non-Illicit Discharge Concerns: Yes
Comments: Outfall pipe is 3/4 full of landscape mulch/ debris and is in need of cleaning.

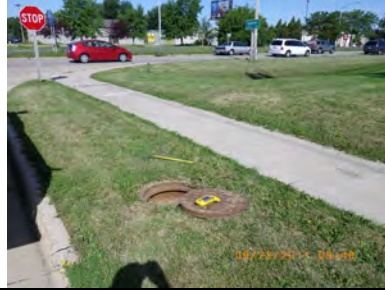
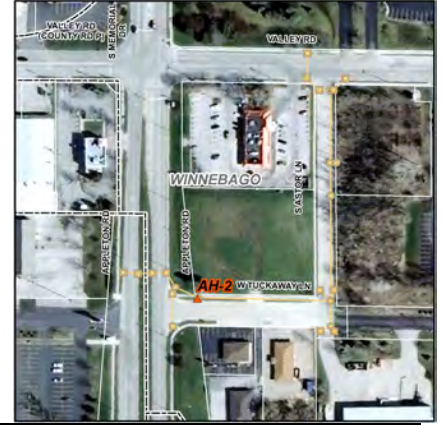
Outfall Location: Tuckaway La storm sewer discharges into STH 47 right-of-way. (Formerly AH-1-Y)
Outfall Description: Concrete MH

Flow: None
Physical Indirectors: None
Overall Outfall Characterization: Unlikely
Non-Illicit Discharge Concerns: No
Comments: Slight standing water in bottom of channel, but no flow.

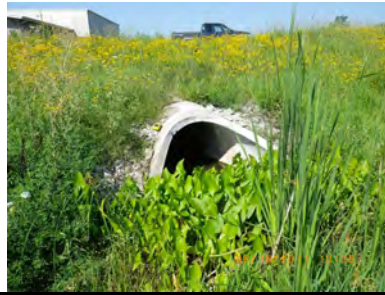
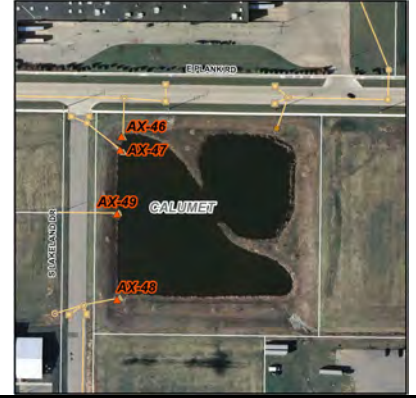
Outfall Location: Southwest pond inlet pipe. (Formerly AX-28-X)
Outfall Description: 36

Flow: None
Physical Indirectors: None
Overall Outfall Characterization: Unlikely
Non-Illicit Discharge Concerns: No
Comments: Slight sediment buildup from when pipe was submerged.

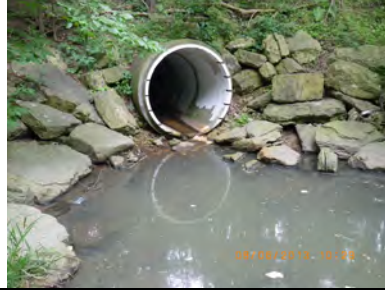
Outfall Location: 72 RCP discharges to ravine from south. (Formerly CC-15-X1)
Outfall Description: 72

Overall Outfall Characterization: Potential (Presence of one or more indicators)
Non-Illicit Discharge Concerns: No
Comments: Infrastructure satisfactory. Oil sheen present, brown suds, and a 6.0 ppm ammonia residual present. Source is a cracked storm sewer on the premises of the WWTP, allowing biosolids leachate to enter the outfall. City is presently rehabilitating the pipe of concern.

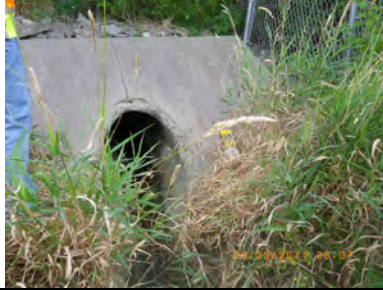
Outfall Location: Outfall #1 at wastewater treatment plant. MS4 drainage per WWTP. No formal outfall name. (Formerly WWTP1)
Outfall Description: 24

Indicator	Description	Comments
Outfall Damage:		
Deposits / Stains:		
Abnormal Vegetation:		
Poor Pool Quality:	Oil Sheen	Very slight sheen on standing water in outfall.
Pipe Benthic Growth:

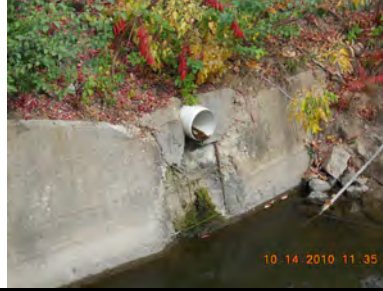
Indicator	Description	Comments
Outfall Damage:	Spalling, Cracking Or Chipping	Headwall is cracked around pipe. Exposed rebar below pipe.
Deposits / Stains:		
Abnormal Vegetation:		
Poor Pool Quality:		
Pipe Benthic Growth:	Green

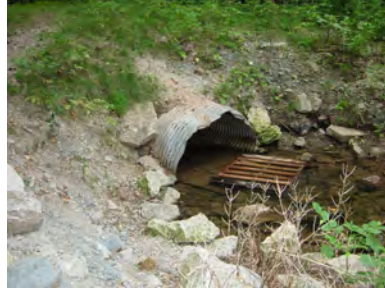
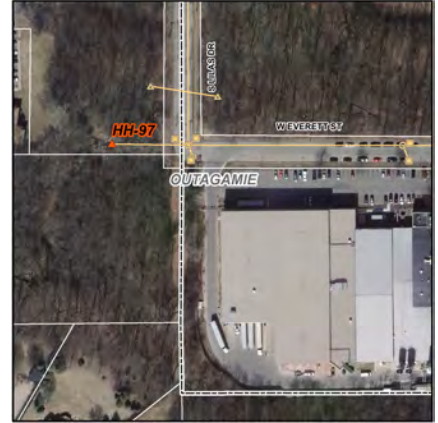
Outfall Location: 36x64 CMP discharges to pool of stream. (Formerly HH-1-X)
Outfall Description: 36x64

Overall Outfall Characterization: Potential (Presence of one or more indicators)
Non-Illicit Discharge Concerns: No
Comments: Free chlorine 0.2. Pipe was replaced. No erosion control devices in place and no established vegetation at time of inspection.

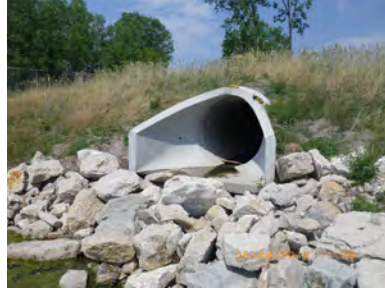
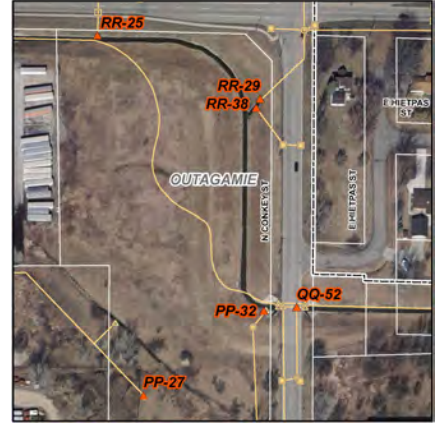
Outfall Description: 66

Indicator	Description	Comments
Outfall Damage:		
Deposits / Stains:		
Abnormal Vegetation:		
Poor Pool Quality:		
Pipe Benthic Growth:	Green

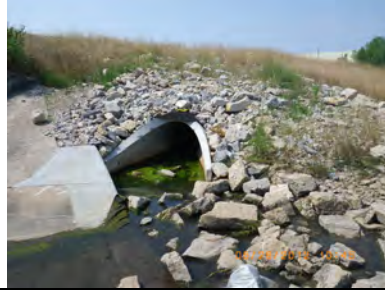
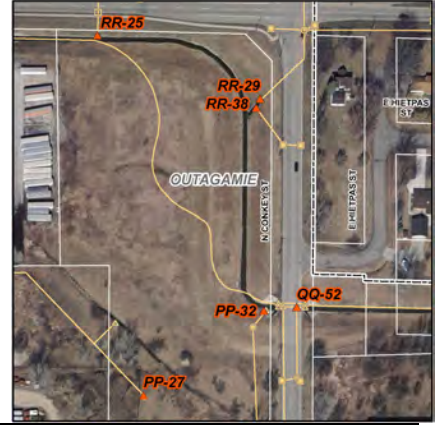
Outfall Description: 36

Indicator	Description	Comments
Outfall Damage:		
Deposits / Stains:	Flow Line	
Abnormal Vegetation:		
Poor Pool Quality:		
Pipe Benthic Growth:	Green

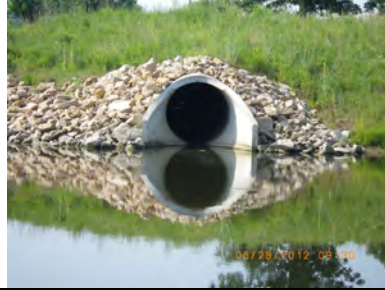
Outfall Location: 66 RCP discharges to Pershing Pond from south. (Formerly QQ-41-X)
Outfall Description: 66

Indicator	Description	Comments
Outfall Damage:		
Deposits / Stains:		
Abnormal Vegetation:		
Poor Pool Quality:	Colors	Cloudy water observed at time of inspection.
Pipe Benthic Growth:

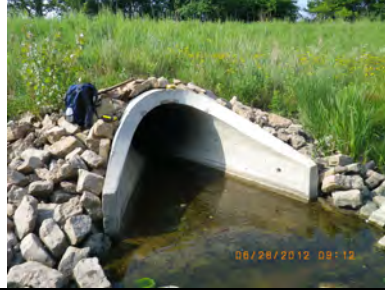
Outfall Location: 36 RCP discharges to Pershing Pond from south. (Formerly QQ-41-X2)
Outfall Description: 36

Indicator	Description	Comments
Outfall Damage:		
Deposits / Stains:		
Abnormal Vegetation:		
Poor Pool Quality:	Colors	Cloudy water observed at time of inspection.
Pipe Benthic Growth:

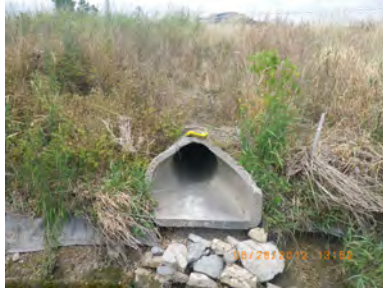
Outfall Description: 18

Indicator	Description	Comments
Outfall Damage:		
Deposits / Stains:		
Abnormal Vegetation:	Excessive	
Poor Pool Quality:		
Pipe Benthic Growth:

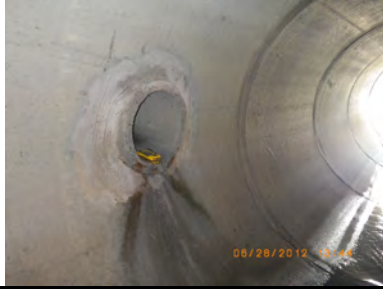
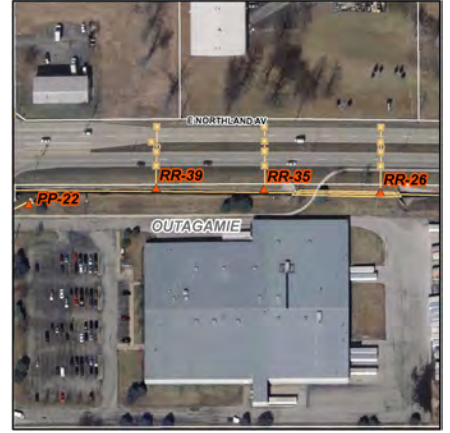
Outfall Description: 18

Indicator	Description	Comments
Outfall Damage:		
Deposits / Stains:	Flow Line	
Abnormal Vegetation:		
Poor Pool Quality:		
Pipe Benthic Growth:

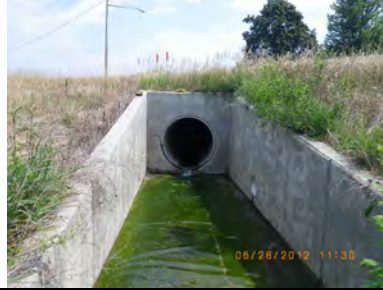
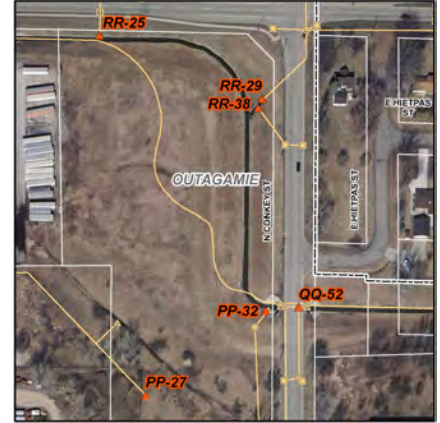
Outfall Description: 48

Indicator	Description	Comments
Outfall Damage:		
Deposits / Stains:		
Abnormal Vegetation:		
Poor Pool Quality:		
Pipe Benthic Growth:	Green

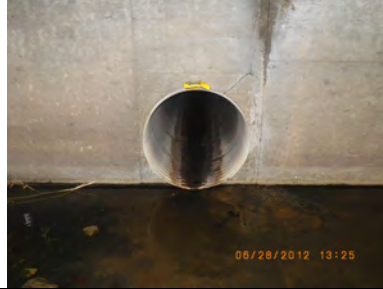
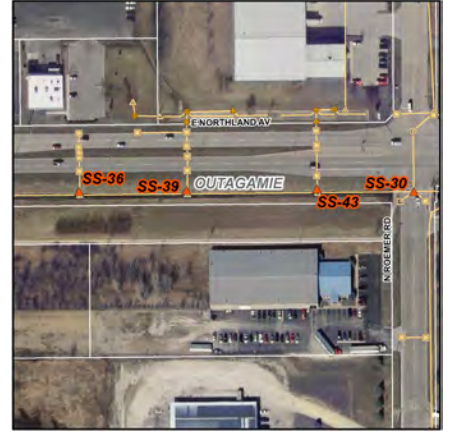
Outfall Description: 36

Indicator	Description
Outfall Damage:	Corrosion
Deposits / Stains:	Flow Line
Abnormal Vegetation:	
Poor Pool Quality:	
Pipe Benthic Growth:

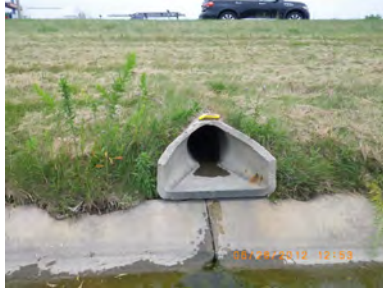
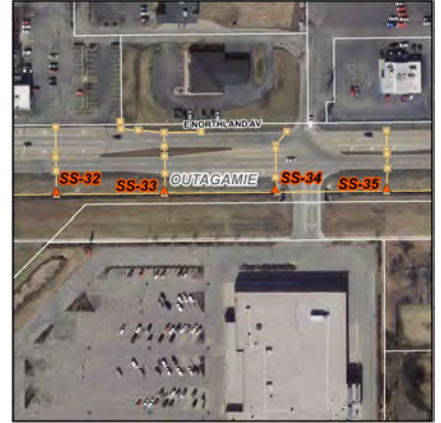
Outfall Description: 18

Indicator	Description	Comments
Outfall Damage:	Spalling, Cracking Or Chipping	
Deposits / Stains:		
Abnormal Vegetation:		
Poor Pool Quality:		
Pipe Benthic Growth:

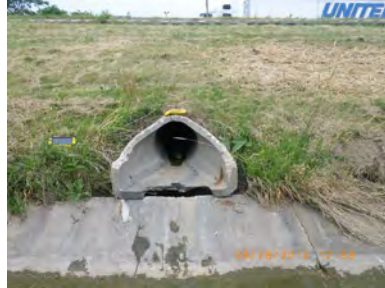
Outfall Description: 18

Indicator	Description	Comments
Outfall Damage:	Spalling, Cracking Or Chipping	Concrete apron is cracked.
Deposits / Stains:		
Abnormal Vegetation:		
Poor Pool Quality:		
Pipe Benthic Growth:

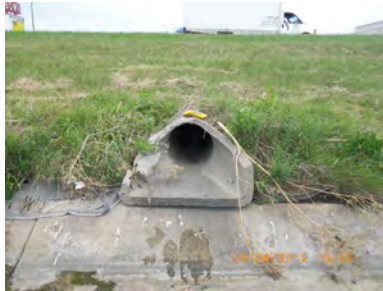
Outfall Description: 18

Indicator	Description	Comments
Outfall Damage:	Spalling, Cracking Or Chipping	One side of the concrete apron is chipped.
Deposits / Stains:		
Abnormal Vegetation:		
Poor Pool Quality:		
Pipe Benthic Growth:

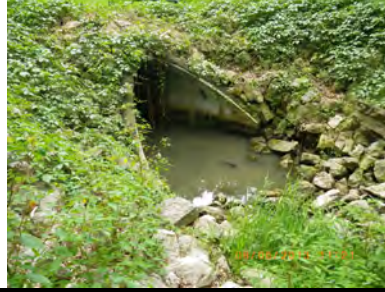
Indicator	Description	Comments
Outfall Damage:		
Deposits / Stains:		
Abnormal Vegetation:		
Poor Pool Quality:	Excessive Algae	Temper flow diversion for Red Oak Ravine construction.
Pipe Benthic Growth:

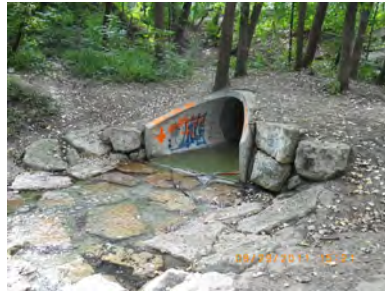
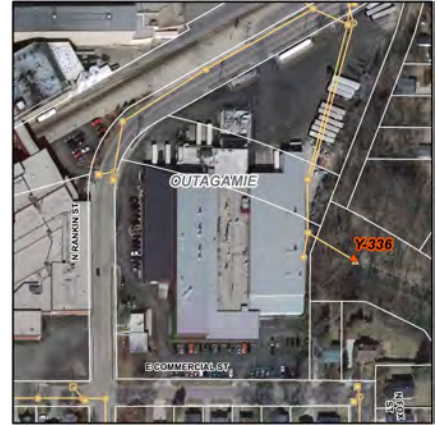
Outfall Location: 54 RCP discharges to riprap channel. Ultimately discharges through NN-1-X. (Formerly Y-266-X)
Outfall Description: 54

Indicator	Description	Comments
Outfall Damage:	Graffiti	
Deposits / Stains:		
Abnormal Vegetation:		
Poor Pool Quality:		
Pipe Benthic Growth:

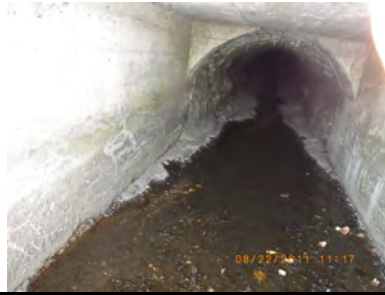
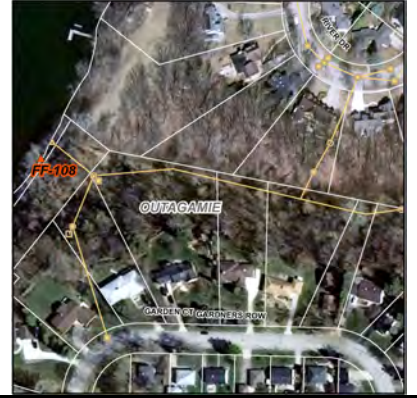
Outfall Location: Stone, brick and concrete pipe arch. (Formerly FF-42-X)
Outfall Description: 55x70

Indicator	Description	Comments
Outfall Damage:	Spalling, Cracking Or Chipping	
Deposits / Stains:		
Abnormal Vegetation:		
Poor Pool Quality:		
Pipe Benthic Growth:

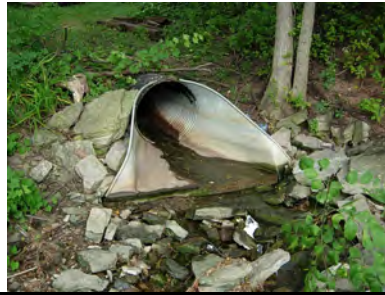
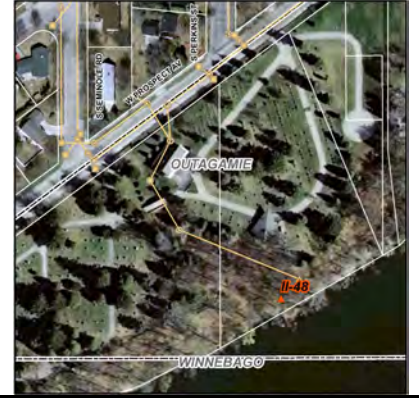
Outfall Location: 36 CMP discharges to river. (Formerly II-1-X)
Outfall Description: 36

Indicator	Description	Comments
Outfall Damage:	Corrosion	
Deposits / Stains:		
Abnormal Vegetation:		
Poor Pool Quality:	Colors	
Pipe Benthic Growth:

Overall Outfall Characterization: Potential (Presence of one or more indicators)
Non-Illicit Discharge Concerns: Yes
Comments: -88.44043375000, 44.24443011111. Severe pipe corrosion, pipe and pan are perforating. Major soil erosion contributing to this outfall. pH and temp only analyzed, as the turbidity will skew the colorimeter results. Green Bay Pipe & TV was televising and cleaning pipes nearby, likely the source of the color and turbidity.

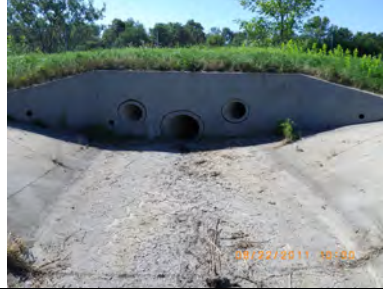
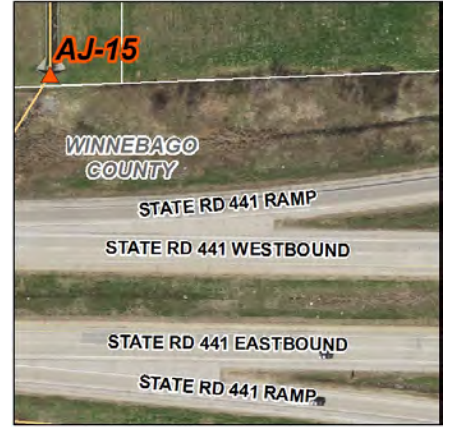
Indicator	Description	Comments
Outfall Damage:		
Deposits / Stains:	Flow Line	
Abnormal Vegetation:		
Poor Pool Quality:		
Pipe Benthic Growth:

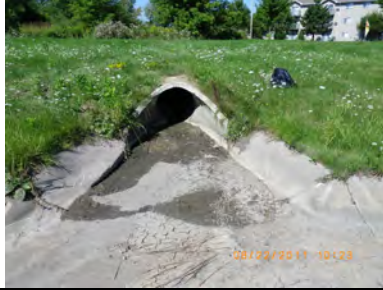
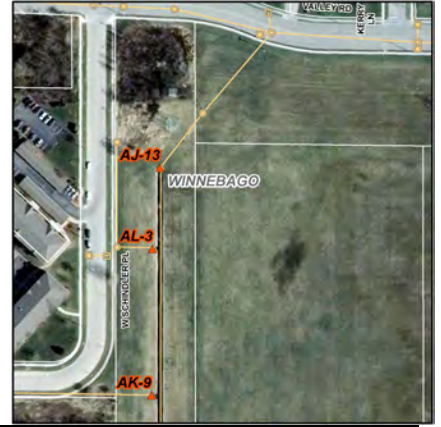
Indicator	Description	Comments
Outfall Damage:		
Deposits / Stains:		
Abnormal Vegetation:		
Poor Pool Quality:		
Pipe Benthic Growth:	Green

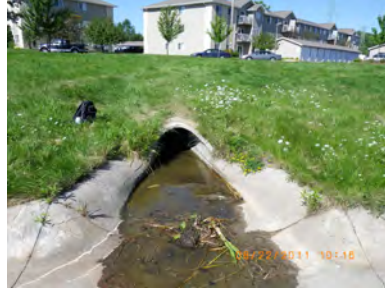
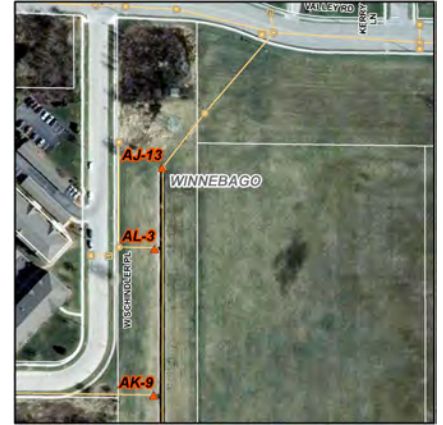
Indicator	Description	Comments
Outfall Damage:		
Deposits / Stains:		
Abnormal Vegetation:		
Poor Pool Quality:		
Pipe Benthic Growth:	Green

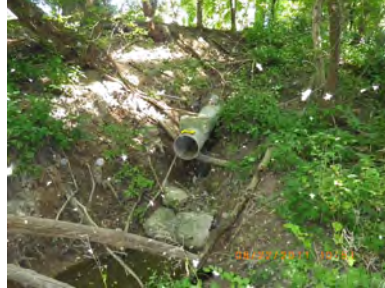
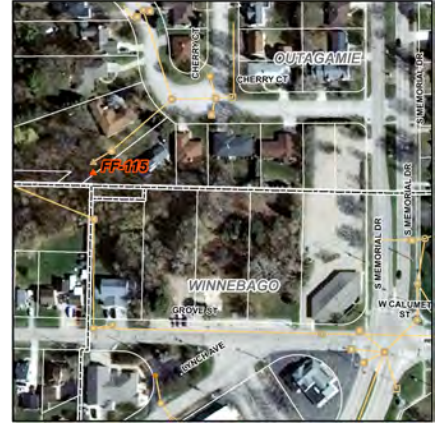
Indicator	Description	Comments
Outfall Damage:	Corrosion	Slight corrosion
Deposits / Stains:		
Abnormal Vegetation:		
Poor Pool Quality:		
Pipe Benthic Growth:

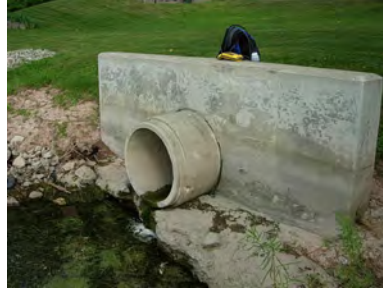
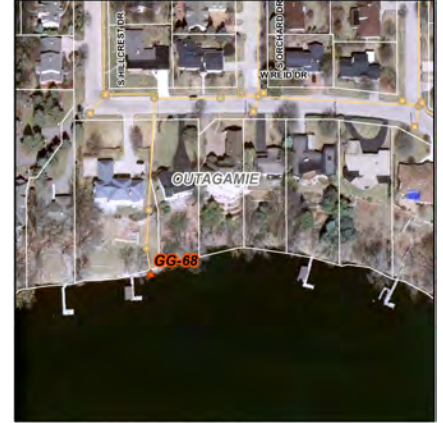
Indicator	Description	Comments
Outfall Damage:		
Deposits / Stains:		
Abnormal Vegetation:		
Poor Pool Quality:		
Pipe Benthic Growth:	Green

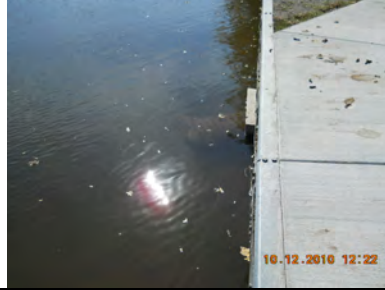
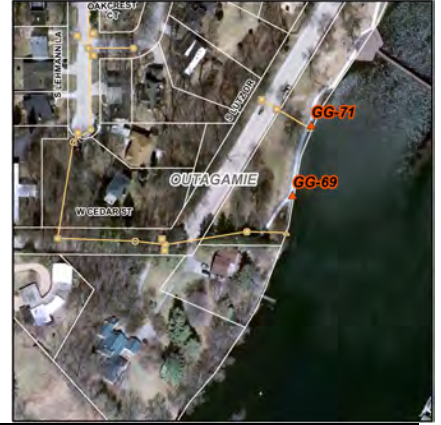
Indicator	Description	Comments
Outfall Damage:	Corrosion	
Deposits / Stains:		
Abnormal Vegetation:		
Poor Pool Quality:		
Pipe Benthic Growth:

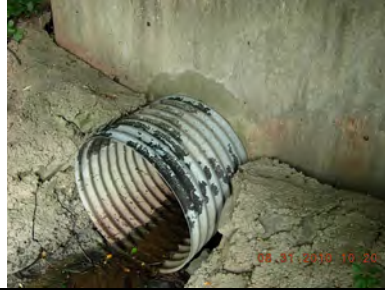
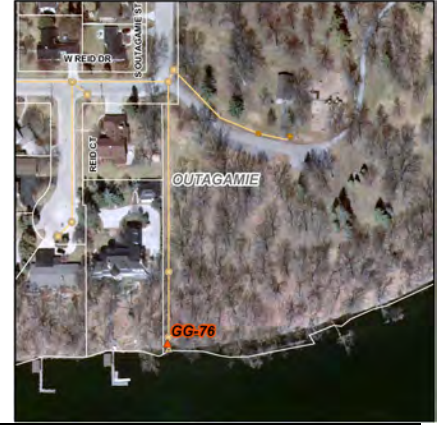
Outfall Location: 30 CMP extends through concrete headwall and discharges into river. (Formerly GG-13-X)
Outfall Description: 30

Indicator	Description	Comments
Outfall Damage:	Corrosion	
Deposits / Stains:		
Abnormal Vegetation:		
Poor Pool Quality:		
Pipe Benthic Growth:

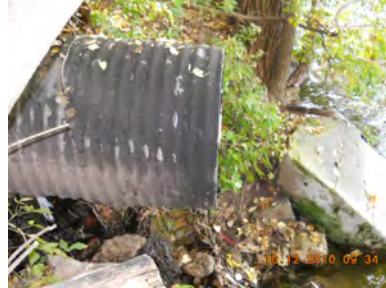
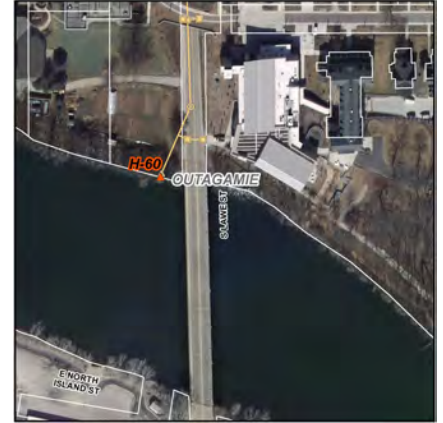
Indicator	Description	Comments
Outfall Damage:	Corrosion	Bottom third of pipe is completely corroded away.
Deposits / Stains:		
Abnormal Vegetation:		
Poor Pool Quality:		
Pipe Benthic Growth:

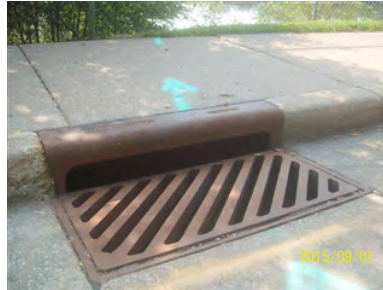
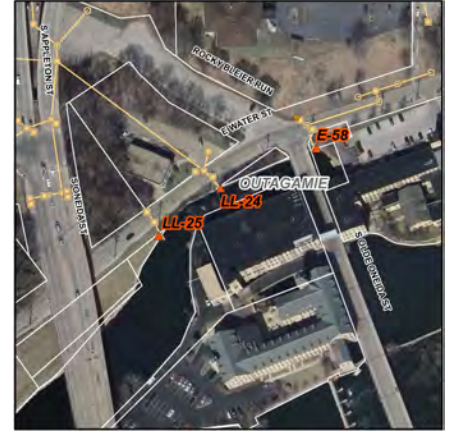
Outfall Description: Concrete MH

Conveyance Type:	Close Pipe
Material:	Manhole - Concrete
Shape:	Manhole - Concrete
Number of Pipes:	1
Diameter:	10"
Submerged in Water:	No
Submerged in Sediment:	No

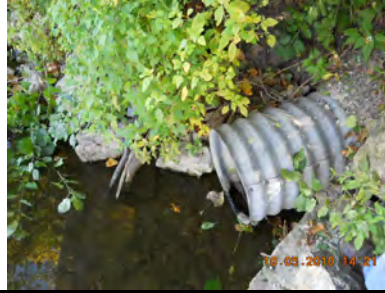
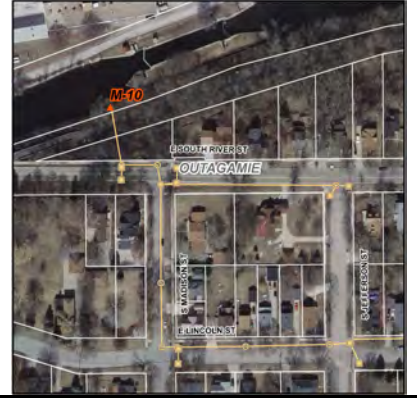
Outfall Location: 15 CMP discharges to river. (Formerly M-1-X)
Outfall Description: 15

Conveyance Type:	Close Pipe
Material:	CMP
Shape:	Circular
Number of Pipes:	1
Diameter:	15"
Submerged in Water:	No
Submerged in Sediment:	No

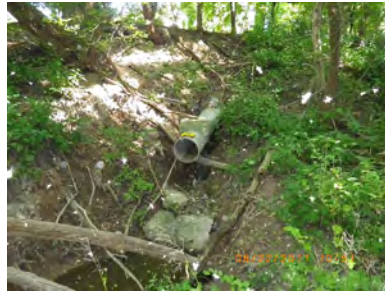
Outfall Description: 15

Indicator	Description	Comments
Outfall Damage:	Corrosion	Slight corrosion
Deposits / Stains:		
Abnormal Vegetation:		
Poor Pool Quality:		
Pipe Benthic Growth:

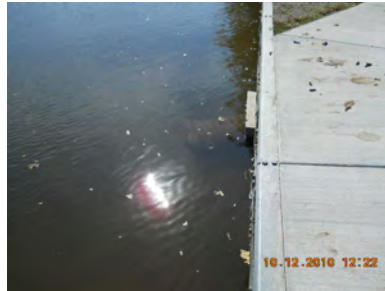
Outfall Description: 18

Indicator	Description	Comments
Outfall Damage:	Corrosion	
Deposits / Stains:		
Abnormal Vegetation:		
Poor Pool Quality:		
Pipe Benthic Growth:

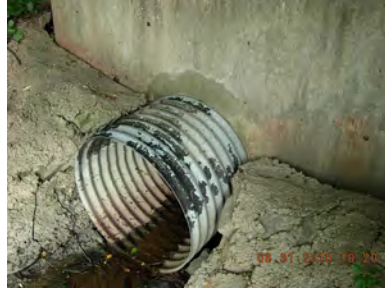
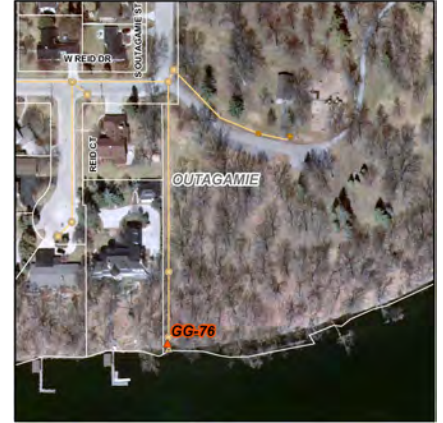
Outfall Description: 30

Indicator	Description	Comments
Outfall Damage:	Corrosion	
Deposits / Stains:		
Abnormal Vegetation:		
Poor Pool Quality:		
Pipe Benthic Growth:

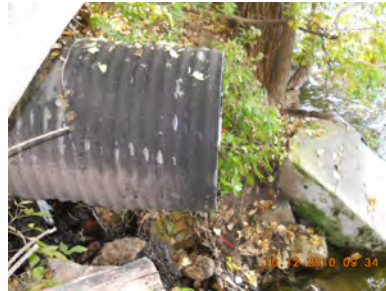
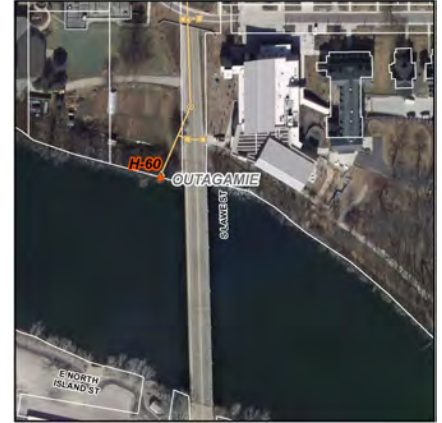
Outfall Description: 36

Indicator	Description	Comments
Outfall Damage:	Corrosion	Bottom third of pipe is completely corroded away.
Deposits / Stains:		
Abnormal Vegetation:		
Poor Pool Quality:		
Pipe Benthic Growth:

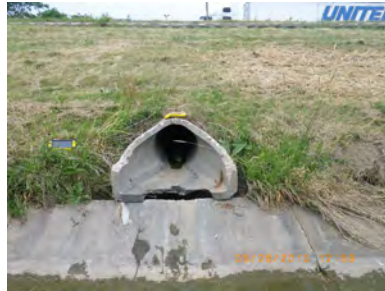
Outfall Description: 18

Indicator	Description	Comments
Outfall Damage:	Spalling, Cracking Or Chipping	Concrete apron is cracked.
Deposits / Stains:		
Abnormal Vegetation:		
Poor Pool Quality:		
Pipe Benthic Growth:
